# WOLF Newsletter

## Pilot project: Joint-sealing in the Johannesgraben tunnel in Stuttgart

**The Johannesgraben tunnel** is a six-lane tunnel at the beginning of the 831 motorway in Stuttgart-Vaihingen. It is 220 Meter long and was constructed in 1979.

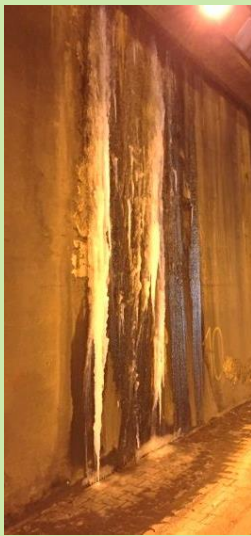
##### Winter

#### On-site installation situation

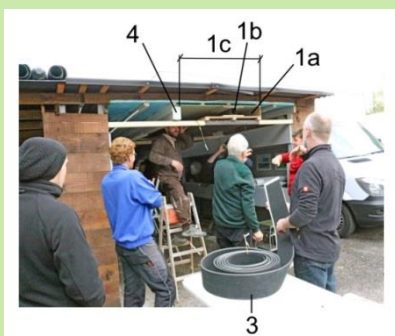
Photo: Training of the installation team

1a: Surface covered in gravel, grain size 3 - 8 mm

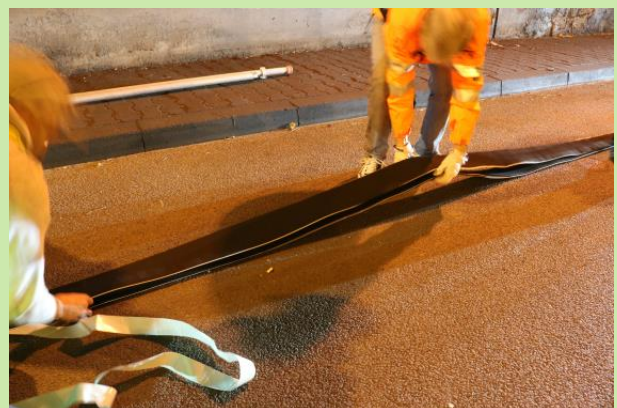
### Solution:

Two joint-sealing cushions of type L, width 13.5 cm, are placed on top of each other on-site and glued together. The sealing cushions are suitable for sealing heights of up to 12 cm.

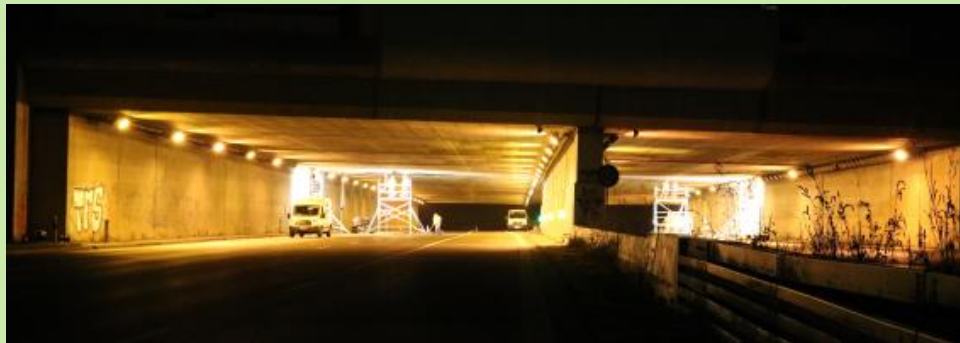
In practice: Mr Neumann used a camera to analyse the state of the overhead joint cavities. Unfortunately, they were so damaged by previous gel sealing material that extra repairs on the joint edges were necessary after provisional sealing with Wolf sealing cushions.

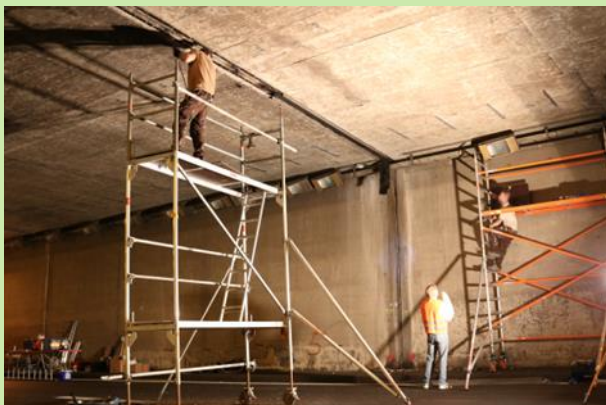
Construction crews 3 and 4, Stuttgart direction

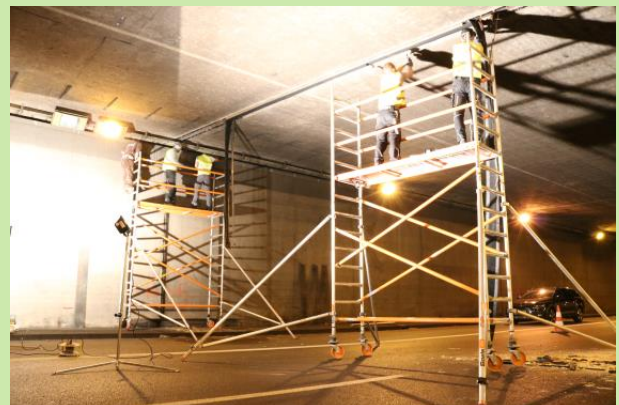
Construction crews 1 and 2, Singen direction

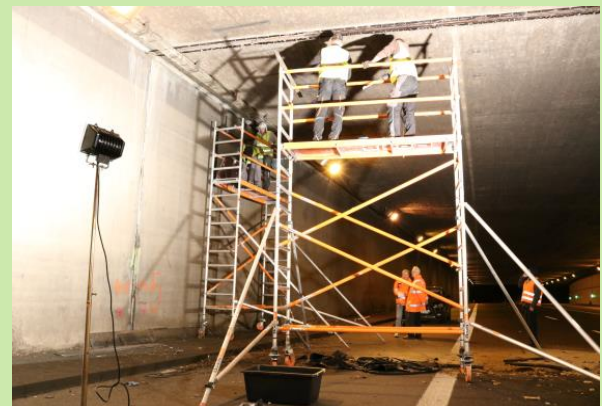
The state of the construction was documented throughout the 12-hour installation period by specialists Professor Flohrer, Mr Neumann, Mr Stoll and Mr Roland Wolf, who worked at a height of 5 m in unfavourable conditions.

Prof. Flohrer's assessment of the debris in the supports raised further difficulties. The poor condition of the surface at the back of the support, segment 4/5, meant that extensive clean-up operations were necessary.

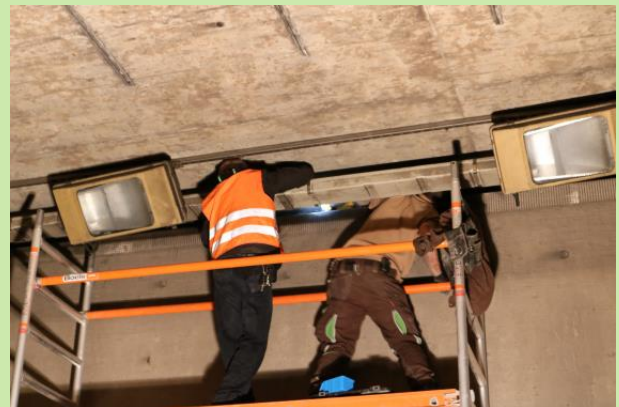
Debris in the support area

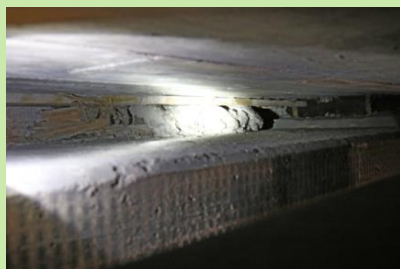
Support area

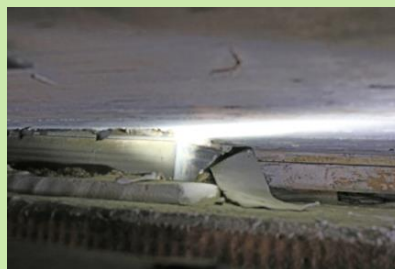
Concrete debris

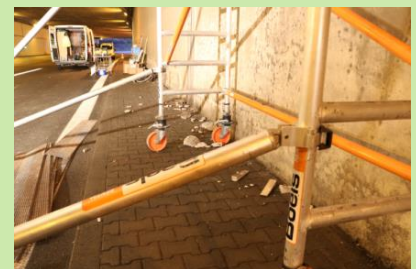
Concrete debris, formwork timber and nails

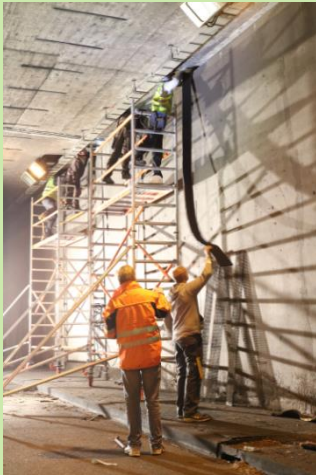
Sealing cushions for the support and ceiling element areas were pulled into the back of the ~ 20-cm wide support area over a length of 8 m.

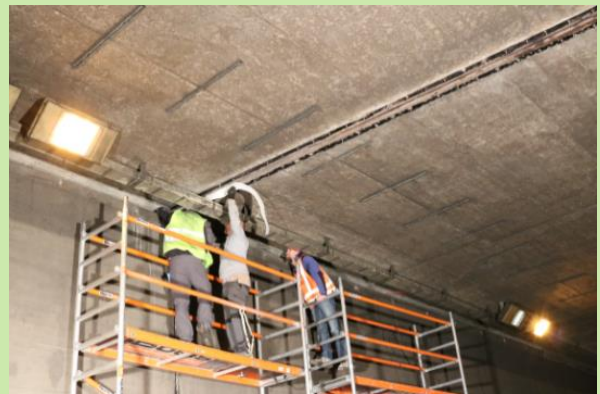
Under supervision, the sealing cushion for the outer wall ceiling element was installed across the previously installed cushion for the support.

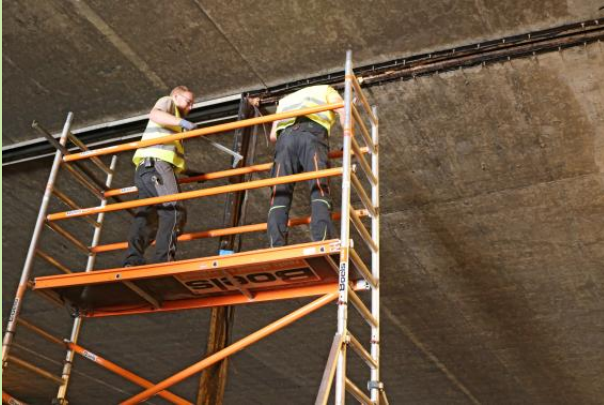
A total of ~ 190 kg backfill material was removed from the joints

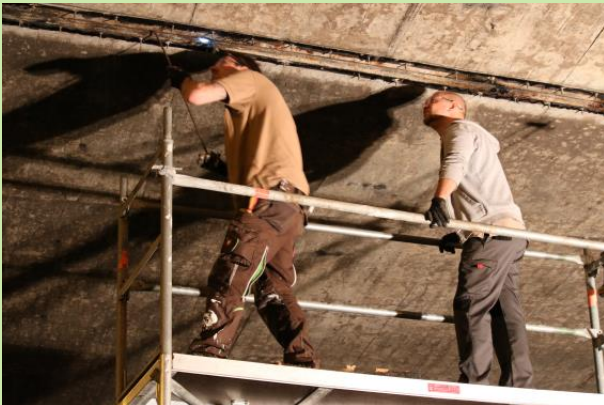
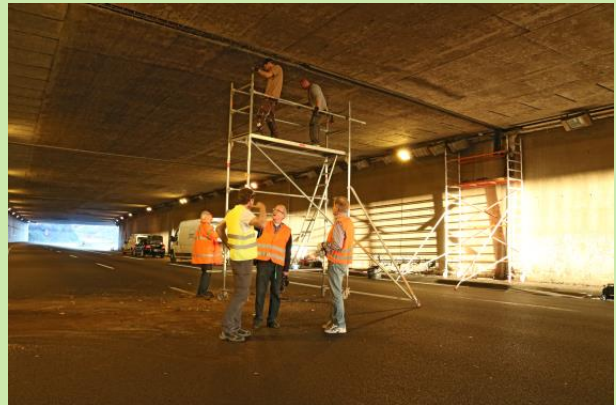
Where the joint edges were damaged due to injection channel drillholes, it was almost impossible to install the temporary sealing cushions for the ceiling joints.

Photo right: Injection ports

Photo below: Joint edges damaged by injection; ports and chipped areas in the ceiling joint of the Johannesgraben tunnel

All damaged areas, including over 140 injection boreholes would need to be completely repaired.

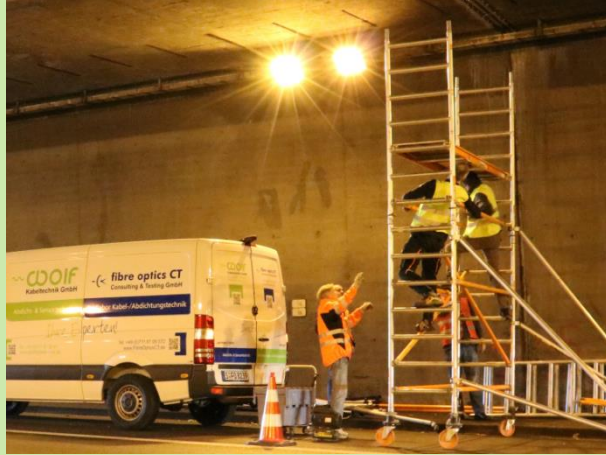
The air was then removed from the 19-metre overhead joint-sealing cushion

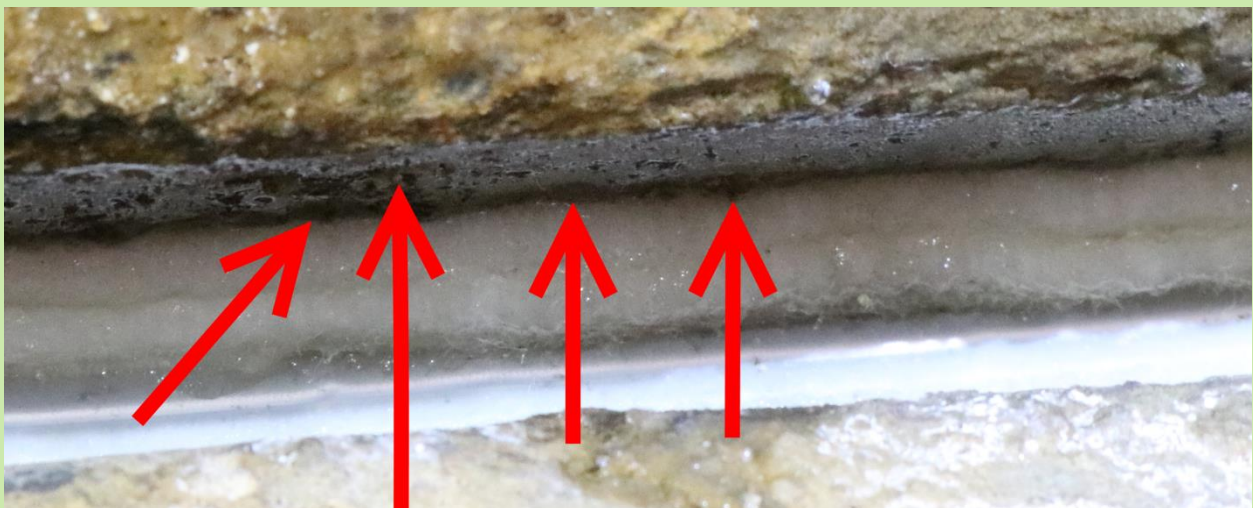
The concrete had partly flaked off to such an extent that the damaged areas could not be covered by the sealing cushion. (Photo, below)

We consider that reliable joint seals with the sealing cushions can only be achieved if the joints are repaired beforehand.

In order to attain full tightness, for which the manufacturer will give a 4-year product guarantee, the joints surface must be smoothed up to the level of the cushion with a special mortar.

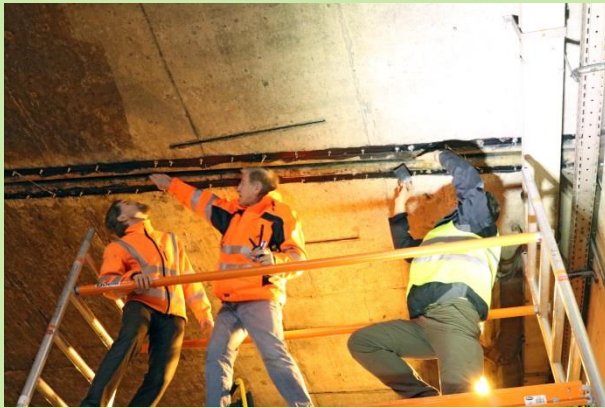
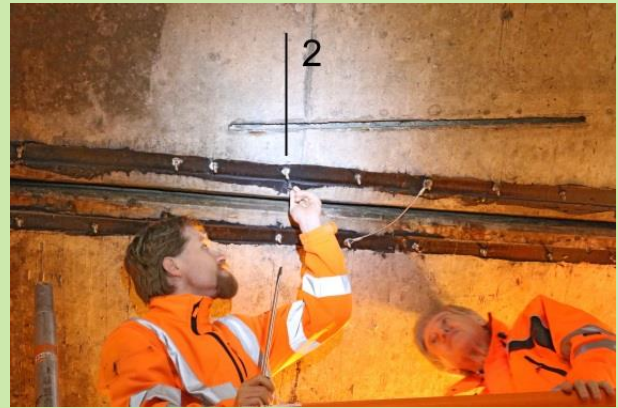
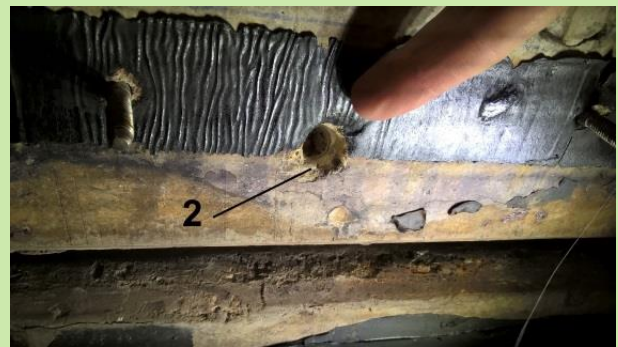
Due to partial closure of the road, Mr Stoll and Mr Neumann, experts from Stone Engineering, were only able to inspect and assess the edge damage in the central overhead joint over a length of 3 m.

- 1 Hole
- 2 Injection channel drillholes

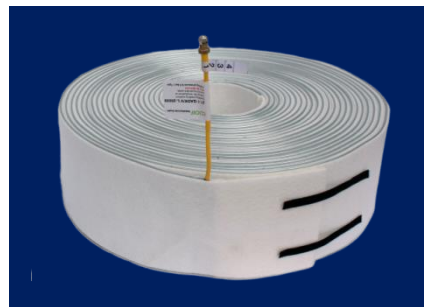
### Art. No. 21.1 QADK/V L

Reusable swelling sealing cushion for joints in bridges, tunnels or buildings subject to **longitudinal or circular movement**

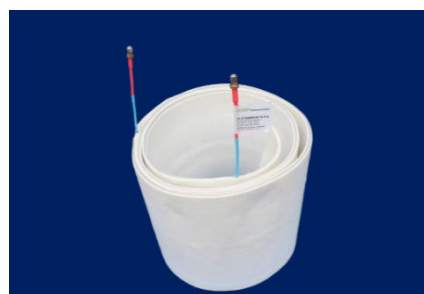
### Art. No. 21.2 QADK/VV

Reusable swelling sealing cushion, for **central wall expansion joints** (with 2 tyre valve connections)

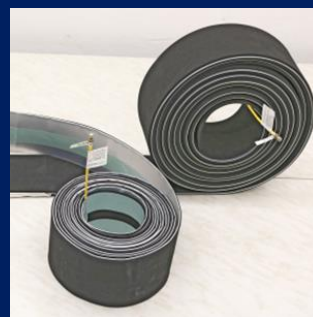
### Art. No. 21.95 ZK6-ADK/V

Reusable swelling sealing cushion with cellular rubber for **support benching** (Lengths of sealing cushion that are glued on top of each other)

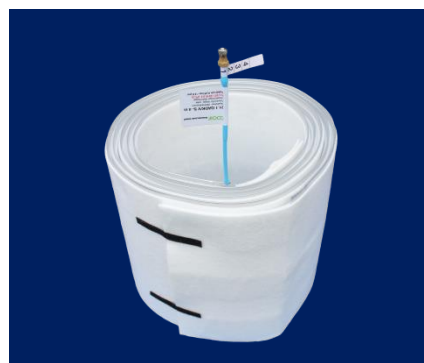
### Art. Nr. 21.1 QADKV S

Bewegungsfugen-Abdichtung (Ventil)

Für Längs- und Querfugen in Brücken. Temporäre Abdichtung gegen Eiszapfen- und Glatteisbildung

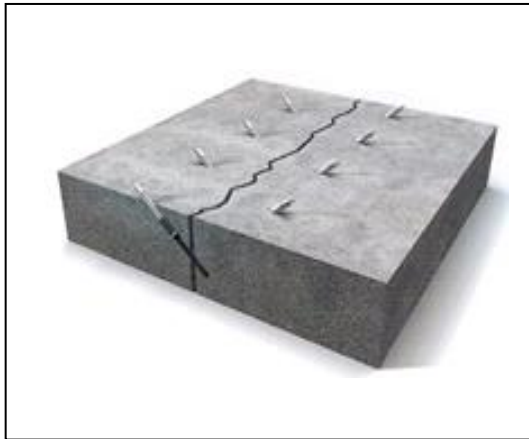
Sketch showing injection
